## British Army Larkspur era C41/R222 Radio Relay: repair and testing, also incorporating the PG342 Frequency Synthesiser. Part 2

Brian Blackwell G3YVW

### Equipment – general description

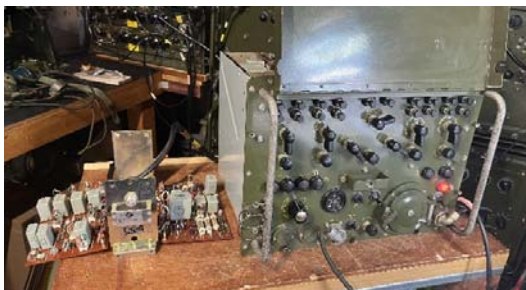
**Figure 3. The carrier set telephone removed from its case and repairs/testing underway. Note the PCB is removed from the unit and checked externally with the aid of the extension cable supplied with the unit**

To aid the checking for correct operation of the carrier set an inbuilt test unit (TMS) system with a multiway selector switch and meter are used. The PCBs can be removed (one at a time) from the unit for testing externally with the aid of a McMurdo 16-way extension cable supplied with the unit. The PCB in **Figure 3** is connected into the carrier set telephone with this connecting lead.

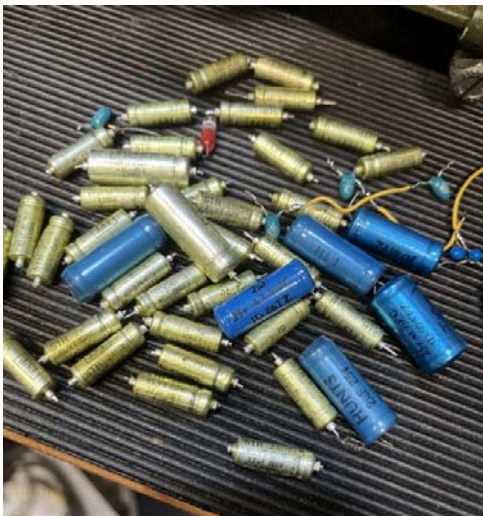
Upon switching on (once the usual safety/preliminary checks had been carried out) all that actually functioned appeared to be only the BATT CHECK (battery check) and the RING GENR (ring generator) as observed on the TMS. So fault-finding began, only to discover quite quickly that most of the internal modules/PCBs were faulty *i.e.* those that utilised certain electrolytic capacitors (2.2  $\mu$ F and 4.7  $\mu$ F) – namely all of those manufactured by ITT and Hunts, and were all faulty. All of these were therefore replaced on sight – a selection of the faulty capacitors is shown in **Figure 5**.

Other faults found were a faulty diode in one of the channel balanced modulators, including a faulty balance potentiometer in the same modulator. Also discovered - as the result of a previous attempt at repair (presumably!) - a large solder 'blob' shorting out PCB tracks, and a transistor on a channel card signalling circuit which had previously been removed and put back the wrong way round.

**Figure 5. A selection of the faulty electrolytic capacitors replaced**

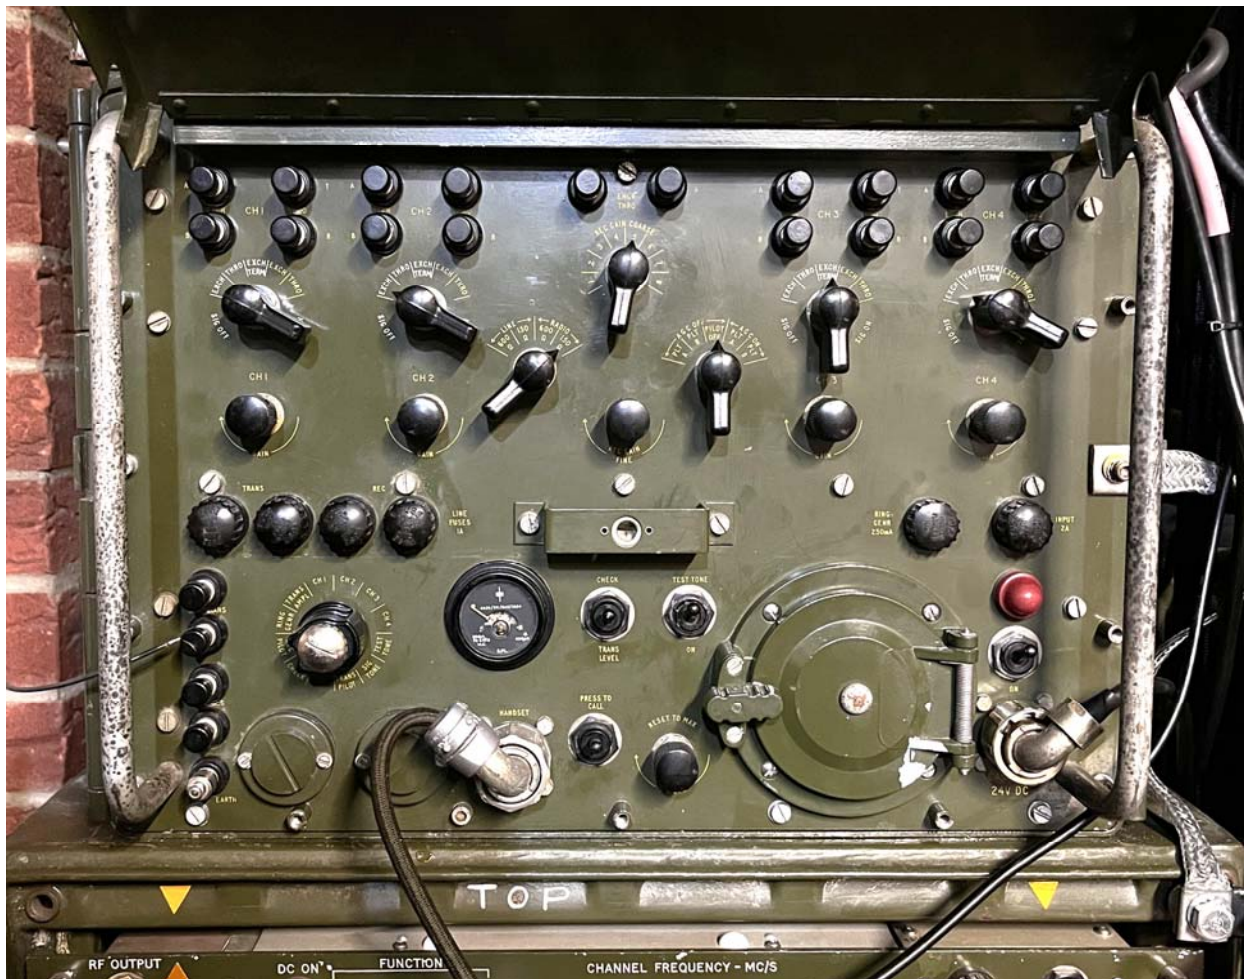
**Figure 6. Front panel layout of the carrier set telephone showing the controls and the TMS unit/meter**

A comprehensive functional test procedure found both in the user handbook and the EMER provided a useful means in which to check the unit for correct operation (in conjunction with the TMS unit and meter) – the front panel layout of which can be seen in **Figure 6**, prior to setting up over a complete system.

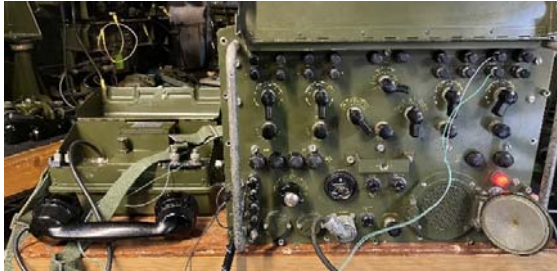
A Telephone Set 'J' field telephone (2-wire) [4] was now connected into a channel input – EXCH 'A' and 'B' terminals (**Figure 8**). The 3.5 kHz signalling tone output (on the appropriate carrier) could be observed on the LINE TRANS. The author could now operate the handset talk switch to speak and observe the audio out on the oscilloscope (again, the (speech spectrum) frequency depending upon which channel/carrier is used). A fairly loud sidetone (from the field telephone) was also heard.

**Figure 8. Testing a channel on the CST 1+4 No. 3 with a field telephone – telephone set J**

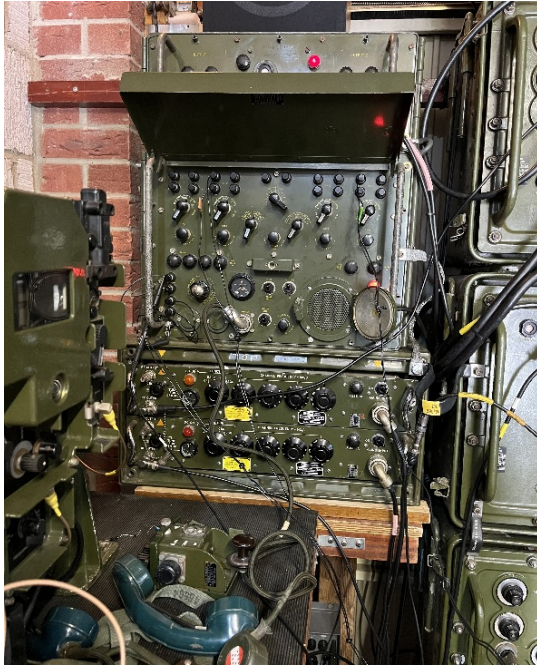
**Figure 10. The carrier set telephone now installed with the C41/R222 radio relay/synthesiser equipment (although not yet connected into the terminal) and undergoing extra testing**

The carrier set was now physically installed into the radio relay/terminal setup as shown in **Figure 10**.

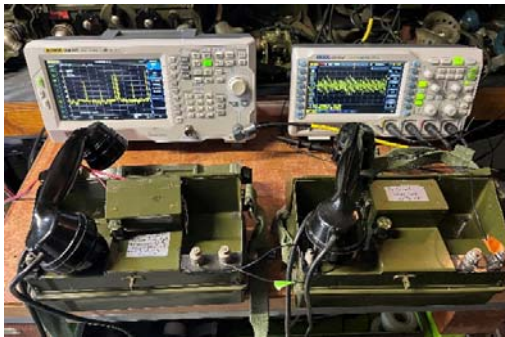
Further tests were now carried out (with the LINE TRANS still disconnected from the LINE REC) and monitoring the LINE TRANS with a spectrum analyser. Additionally, an extra telephone set J was utilised such that two channels could be connected (**Figure 11**).

**Figure 11. The test setup with two telephone set J's, and monitoring the frequency spectrum/baseband with the spectrum analyser and additionally with the oscilloscope**

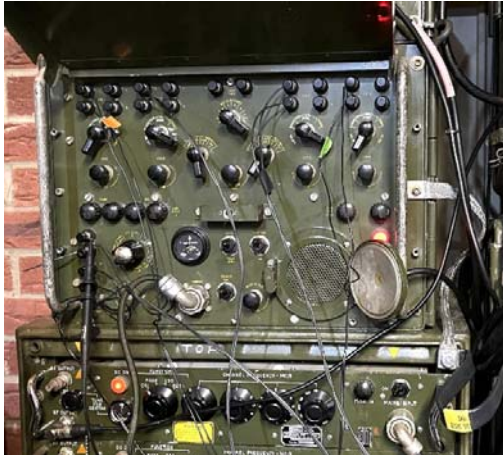
Note the switch settings on the front panel in **Figure 14**:

Channels 1 and 4 – EXCH (SIG ON): both channels enabled (telephone set J inputs) with signalling on

Channels 2 and 3 – EXCH (SIG OFF): both channels enabled (video signal generator inputs) with signalling off

Pilot A and AGC signal on

Selector switch to REC PILOT: monitors the LINE REC input, and the REC GAIN COARSE (and FINE) controls set to give a meter reading accordingly in the central white area

The LINE/RADIO selector switch set to LINE 150  $\Omega$ \*

\*Note both LINE/RADIO impedance positions were additionally tested (with 150/600  $\Omega$ ) – with appropriate adjustments on the R222 attenuator during later tests for correct deviation because the RADIO switch position on the carrier set telephone introduces an 8 dB attenuation.

**Figure 14. Final settings for the testing with the radio relay terminal. Note the meter selector switch is set at REC PILOT, thus monitors (and checks) the REC LINE signal in for the correct level (meter indicator central/in the white zone)**

Note the C41 (and R222) both have a deviation monitor setting on their respective meter selector switches, but an additional Racal meter was used here by the author as a double-check. **Figure 14** shows the carrier set telephone connected into the radio relay terminal setup, and powered from its own (original) 24 VDC supply sitting above. The C41 and R222 oscillator frequencies were set as before, that is, the R222 using its own crystal and the C41 using the Plessey frequency synthesiser.

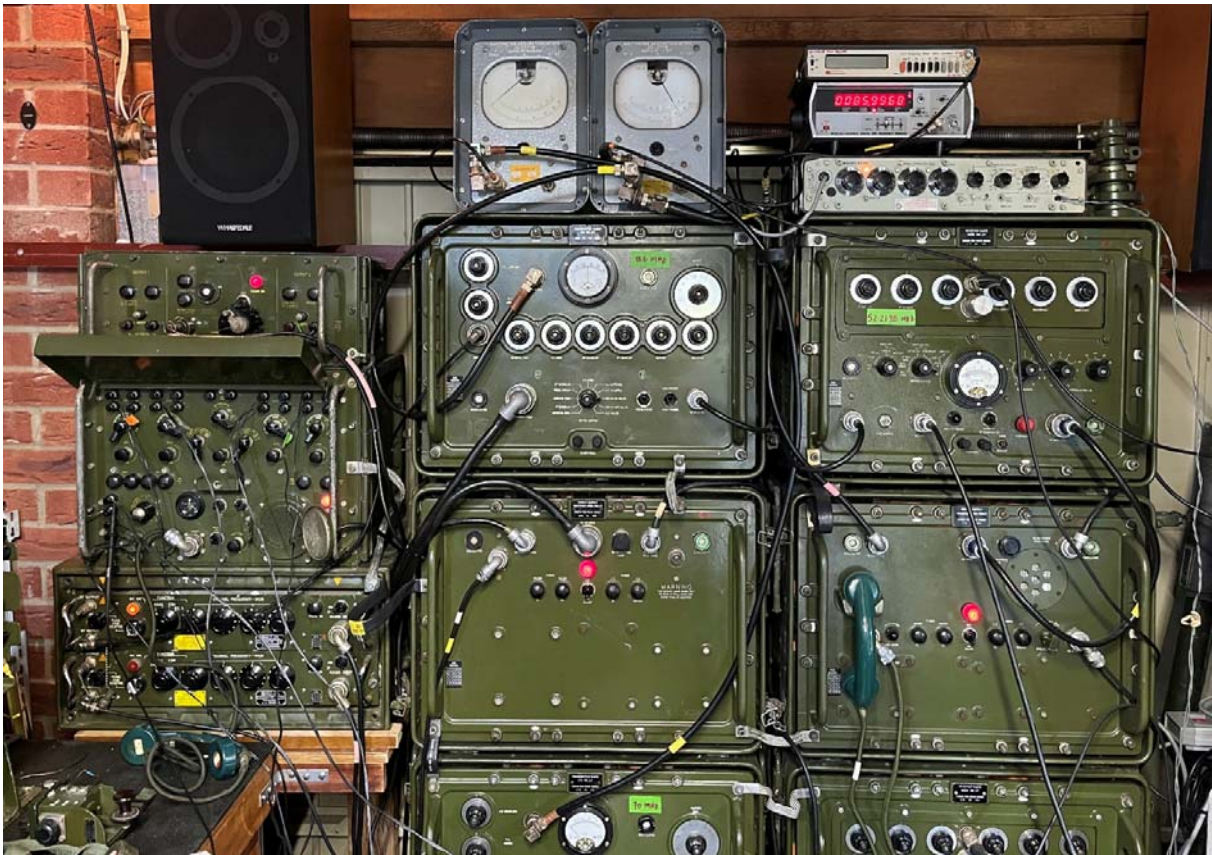
**Figure 15. The final 'operational' setup of the radio relay terminal complete with frequency synthesiser and carrier set telephone/PSU**

The system was powered up, using the Marconi TF2018 to supply an RF input signal to the R222 (52.2198 MHz) and the C41 transmitter RF out (86 MHz) was connected to the CT211 HF wattmeter, Racal frequency counter and the Racal deviation meter. All input/output signal and power levels as before with the previous terminal testing in part 1. The final system test configuration can be seen in **Figure 15**.

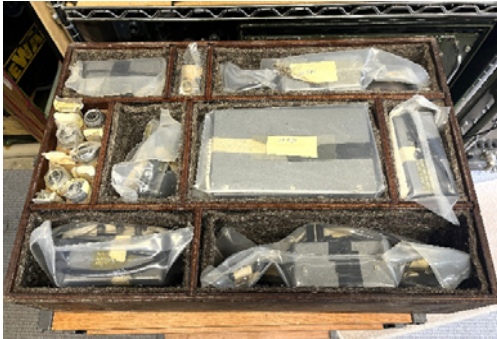
**Figure 16. The recently acquired C41/R222 testing kit**

It is ironic that now the complete system is fully repaired and 'up and running' that the author recently obtained one box (NoS) of a two-box set at a radio boot sale of the C41/R222 station radio testing kit, which included the hard to find test crystals of 50, 75 and 100 MHz for the transmitter C41 and the receiver R222, as can be seen in **Figure 16**.

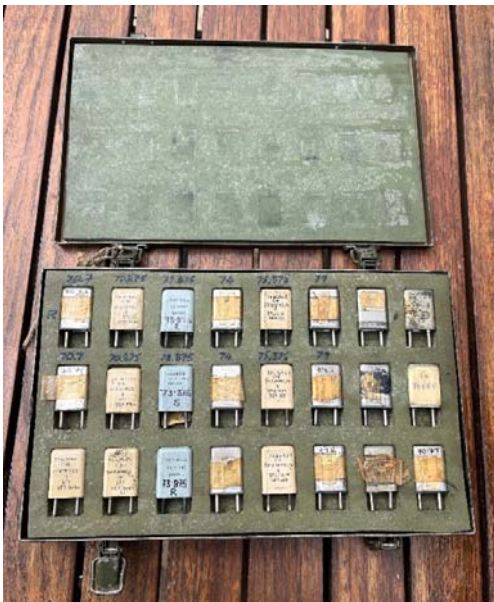
**Figure 17. The recently acquired crystal set**

Also obtained – post repairs, with the carrier set, was a full set of operational crystals that were issued with the C41/R222, as shown in **Figure 17**.
